Pulsar revitalizes measurement accuracy at Soviet-era plant

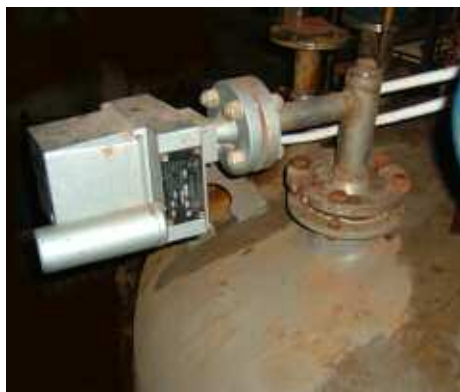
Soviet torque tube displacer transmitter.

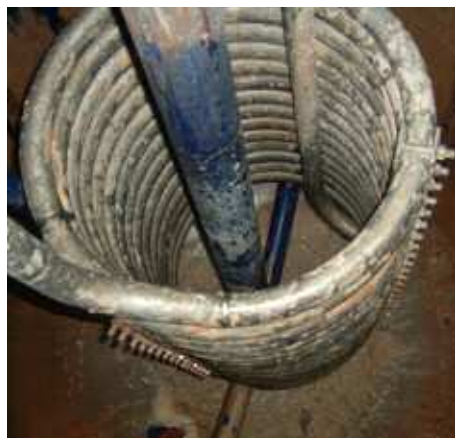
Changing dielectrics defeated old level devices. Note the tank's many internals.

has been problems with changing densities. The liquid in the tank is heated by steam tracing which concentrates the solution. Water vapors are extracted by creating a vacu-

um of approximately -200 to -400 mbarg (-2.9 to -5.8 psig) at temperatures of 120° C (248° F).

An additional challenge of this application is its small tank packed with coiled piping for the steam heating and an agitator. After our evaluation, we recommend Pulsar through-air radar. An extended 4" horn antenna was selected to avoid initial reflection from the round shape of the tank top.
